Investigation and Analysis of Empirical Field Seismic Damage to Bottom Frame Seismic Wall Masonry Structure

L. Siqi^{*a}, Y. Tianlai^a, J. Junfeng^b

doi: 10.5829/ije.2019.32.08b.04

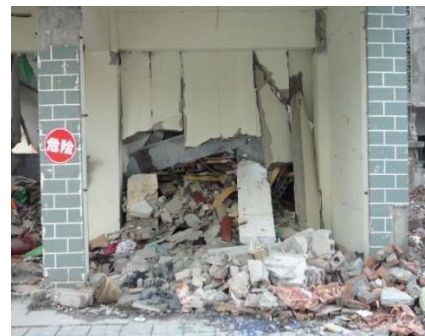
Figure 1. Serious collapse of a bottom frame story

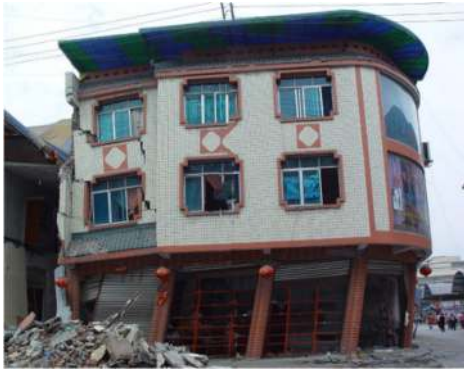
Figure 2. The bottom frame lateral displacement enlargement

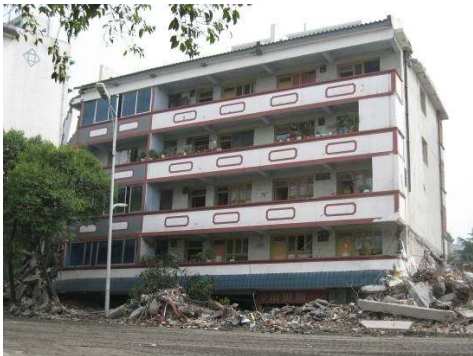
Figure 3. The overall collapse of the bottom layer

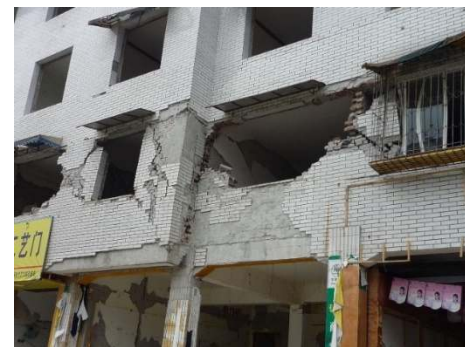
3. 2. Serious Damage to the Transition Story The transition story in the BFSWMS is normally the first story of the upper masonry structure of the bottom frame. The stress and transmission of the transition layer at the junction of the bottom frame and masonry structure are inconsistent. Due to the underlying set of seismic walls, the bottom stiffness is increased compared to structures without aseismic walls on the ground story. Failure to install aseismic walls on the bottom story as required by the aseismic code, because of the requirement for include a bottom partition and for maintenance purposes, partially filled walls have been established, which contribute, to a certain extent, to seismic resistance. The weak layer of the structure moves upward, and the damage to the transition layer is more remarkable than that of other layers. The building seismic code (GB50011-2001) strictly stipulates that when the length of the transition layer wall exceeds 5m, reinforced concrete structural columns shall be added to the wall, avert detrimental behavior of short columns, and strengthen its seismic capacity. However, according to the empirical field seismic damage inspections, The transition story of a portion of the structure fails to comply with the provisions of the seismic design code, which causes serious failure of the story. As indicated in Figure 4a, the transition story experienced serious

destruction, and the bottom frame was lightly damaged even under the action of reciprocating horizontal earthquakes parallel to the wall direction. The characteristics of seismic damage are noted as basically intact, slightly damaged and moderately damaged. As shown in Figure 4b, shear-type one-way or "X" cross-oblique cracks appear in the seismic wall. Although the bottom seismic wall is damaged to a certain extent, the subject frame can still continue to work. However, the stiffness of the transition story is relatively weaker, resulting in serious shear failure of the wall between windows. The stiffness ratio of the bottom frame to the transition story is determined according to the seismic design code, guarantee the average strength coordination between the bottom story and the transfer story, and the lateral stiffness of the transition story is properly strengthened by setting structural tie columns and ring beams.

(a) Partial collapse of a transition layer wall

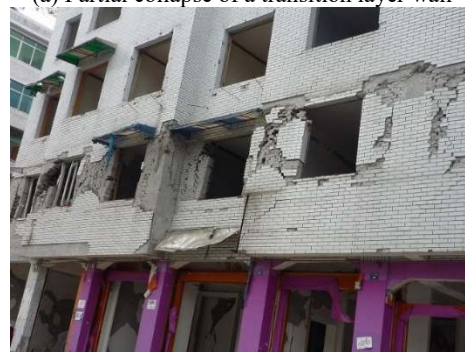
(b) Serious damage to the wall between windows in the transition layer

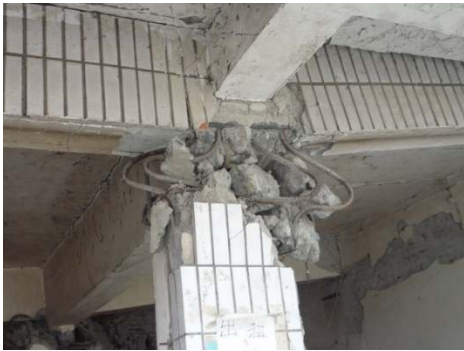
When the vertical load excessively larger, the smaller longitudinal section and the concrete strength are insufficient; the longitudinal reinforcement will buckle into a lantern shape, the stirrups in the column will break or fall off, and the column loses its bearing capacity in the form of buckling failure, as shown in Figure 5.

Figure 5. Serious damage to the top of a bottom frame column

The top of the column and joint are under the combined action of the variable reinforcement, variable diameter, and shear and axial force; together with insufficient stirrups or poor anchorage results in serious failure to the joint location. The space effect of the story and the distributed reinforcement across the story, and the fact that the reinforcement of beams is frequently over-matched in the empirical design, bring about the empirical bending bearing capacity of the end section of frame beams being larger than that of the beam without considering the story action [3]. In the weak layer, the allocated shear force of the frame columns increases, and the shear strength is insufficient. Reciprocating seismic action causes the beam-column joints to be in the state of composite stress. The design should be carried out in strict accordance with the seismic code, and the construction quality shall be guaranteed to improve the structural integrity.

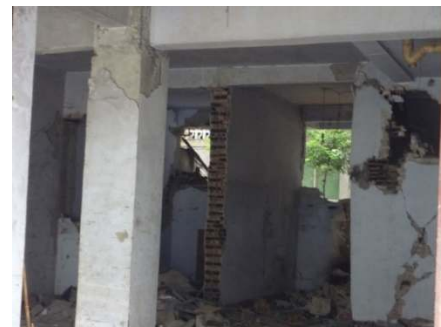
deformation of the frame and masonry wall is inconsistent, the transmission path of a vertical load may changes [12, 13]. To a certain extent, the masonry wall acts as bottom seismic wall and filling wall, as shown in Figures 6a and 6b. Some of the bottom frames of the buildings are basically intact, and the upper masonry structures are seriously damaged. As shown in Figures 7a and 7b, without reasonable consideration of the stiffness settings of the upper masonry structure, enhance the bottom stiffness unilaterally, and the phenomenon of “upper flexibility and lower rigidity” appears. In addition, through field investigation, it is found that the grade of damage to the rear longitudinal wall is remarkable discrepancy due to the multiple orientation of the structure system.

(a) Serious damage to the bottom seismic wall

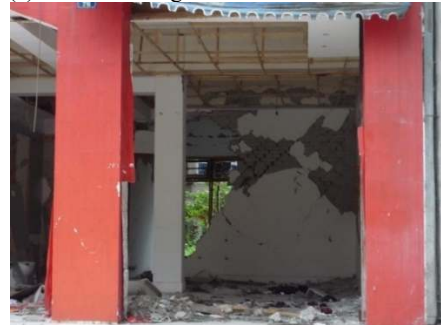
(b) Local collapse of the bottom seismic wall

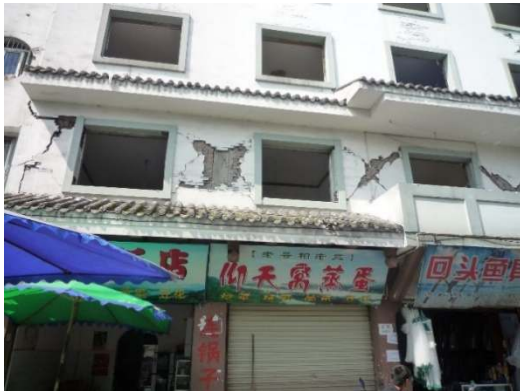
(a) Serious damage to a window wall

Figure 7. The bottom frame basically intact, and the upper masonry structure is seriously damaged

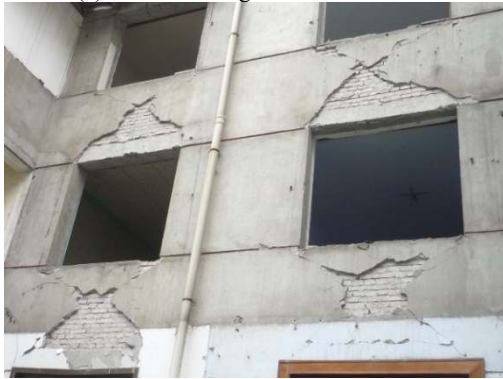
(b) Serious damage to the wall under the window

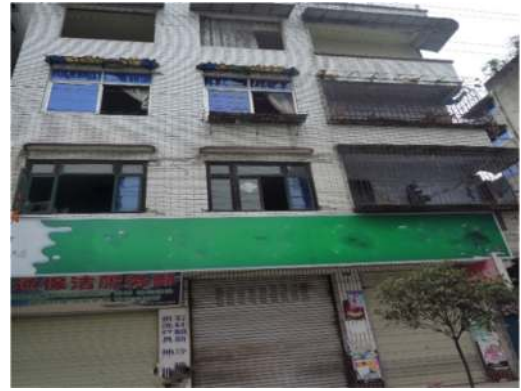
even collapse, and large-scale failure, which leads to the collapse of the first story on the back street and results in the overall tilt of the building backwards, as shown in Figures 8a and 8b; therefore, insufficient width setting, and weak resistance. Most of these buildings have been seriously damaged and cannot meet the requirements of current seismic codes, and need to be strengthened or demolished [5]. The structure type of the bottom should be reasonably arranged to avoid local force inconsistency due to the mixed structure of the bottom; the stiffness ratio control of the bottom and the upper structure should be given full attention.

(a) The side of the mixed bottom frame structure near the street is basically intact

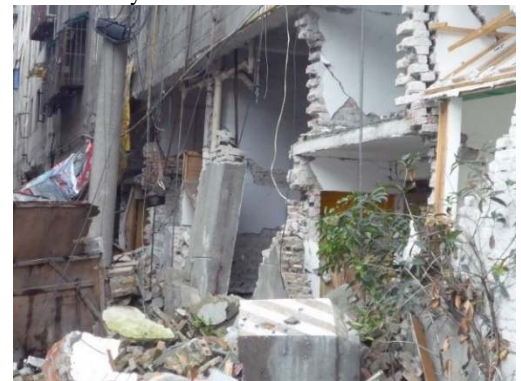
(b) Serious shear failure of the rear longitudinal wall on the side of the back street of the mixed bottom frame structure

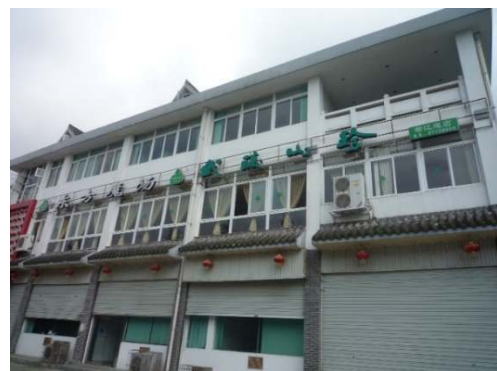
buildings can reasonably meet the stiffness requirements for the bottom and transition storeys by establishing aseismic walls, which produce fine seismic resistance performance, as shown in Figure 9. A proportion of buildings with lower storeys have basically intact structures, which indicates that the seismic performance factors of the structure are related to the number and height of storeys.

Figure 9 Basically intact BFSWMS
