## Studies on Contaminated Mine Soil and Its Remediation using Soil Washing Technique: A Case Study on Soil at Kolar Gold Fields

Uncontrolled mining and the tailings produced can cause significant environmental impacts such as water, air, and soil pollution. In the present study, a contaminated soil of gold mines located in the Karnataka state of India was studied to know the geotechnical behavior of this soil as a foundation material and to suggest a suitable soil remediation technique to avoid contamination of surrounding water bodies. The in-situ dry unit weight of soil at the selected locations varied from 15.71 to 18.75 kN/m<sup>3</sup>. The effective shear strength parameters determined from Triaxial test results were in the range of 4.8 – 8.2 kN/m<sup>2</sup> and 19.4° – 29.8°, respectively, for the cohesion and angle of internal friction. The soil samples were analyzed for bearing capacity and settlement using GEO5 software tool, and the economical dimensions of the footings were estimated. It was observed that the soil has sufficient bearing capacity, and the settlements are within the allowable range. The chemical analysis of the soil samples showed that there are consid

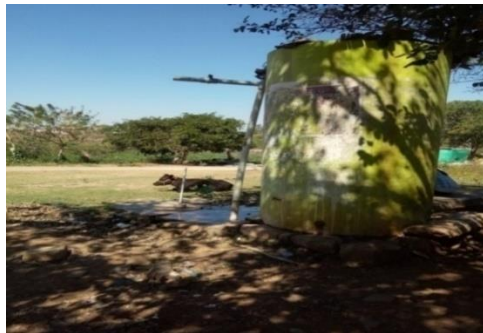
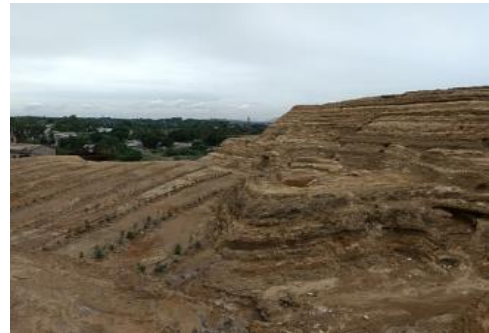
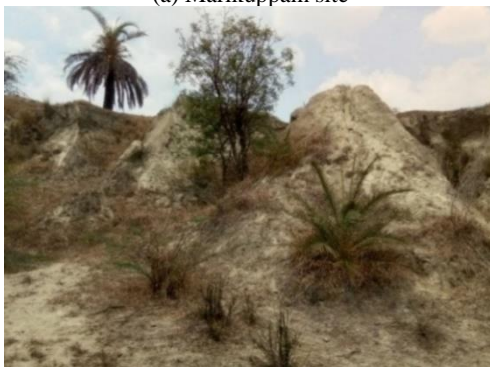
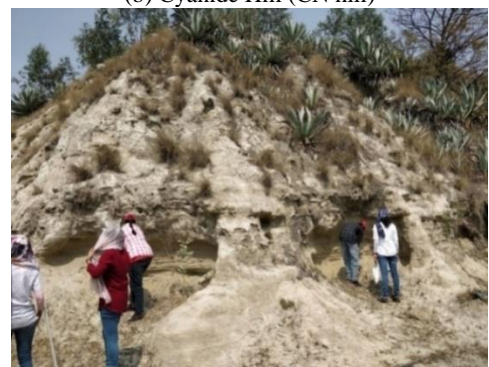
**Figure 2. Photographs at the Selected Locations of Study Area**

(a) Marikuppam site

(b) Cyanide Hill (CN hill)

(c) Coromandel Site

(d) Champion reef- Gifford shaft dump site

The disturbed and undisturbed samples of soil were collected from four major dump sites, i.e., Marikuppam (Residential-oldest dumpsite), Cyanide hill (CN hill), Coromandel and Champion reef- Gifford shaft. The properties of the collected soil samples such as specific gravity, plasticity characteristics, soil classification, compaction characteristics, density and permeability are determined according to the procedures given in various Indian Standard Codes [23-27] which are specified in Table 2.

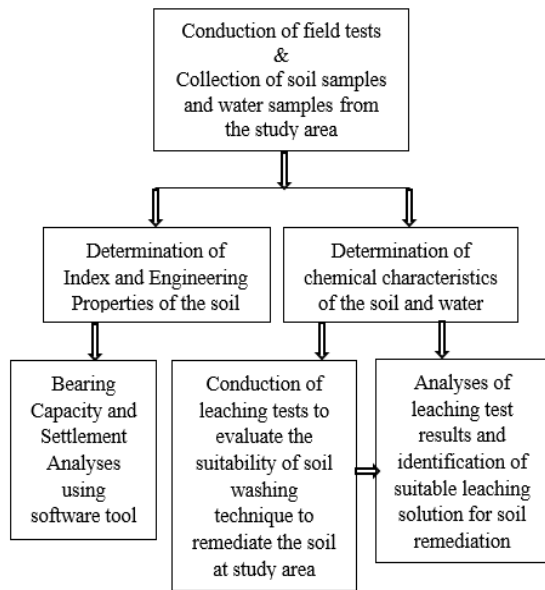
Figure 3. Flowchart of the research methodology

The research methodology of the current research work is shown in the flow chart (Figure 3).

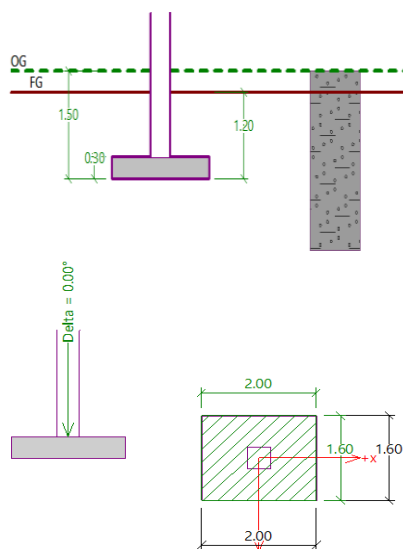
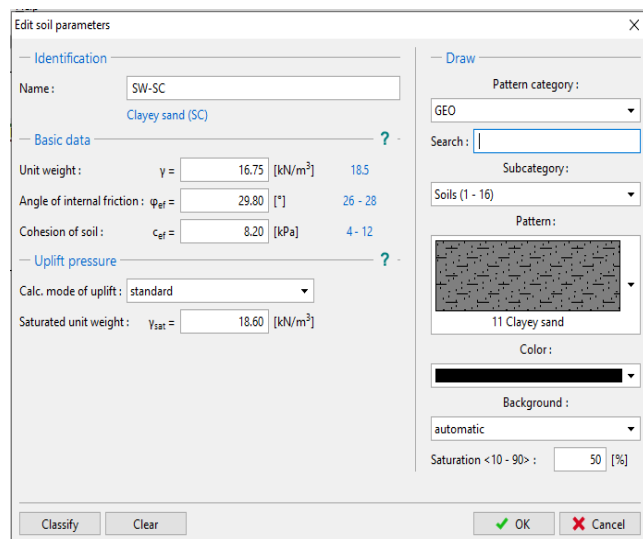
Figure 4. Foundation and Soil Details as Input to GEO5 Software (For Marikuppam Site)

The The results of laboratory experiments were provided as input to the software and the bearing capacity was analyzed for a footing of size 1.6 m x 2 m placed at 1.5 m depth. The vertical load on the footing was taken as 300 kN with a service load of 214.29 kN. The footing details and soil properties are shown in Figure 4 (for Marikuppam soil). From the analysis, the bearing capacity of the Marikuppam soil was estimated as 1001.97 kPa and the factor of safety corresponding to a contact pressure of 112.89 kPa was found as 8.88 which is relatively high. Hence, to get an economical section using the inbuilt functions of the software, the footing size was revised. The revised size, thus obtained from Marikuppam soil is 0.7 x 0.7 m (Figure 5). The CN hill soil was studied in the similar

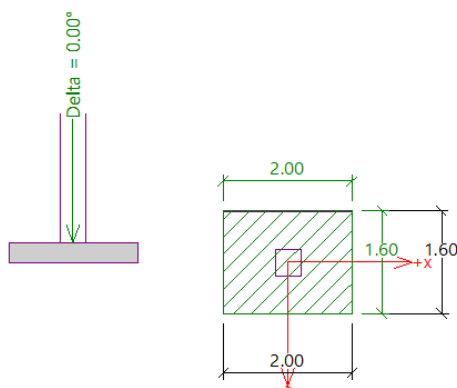
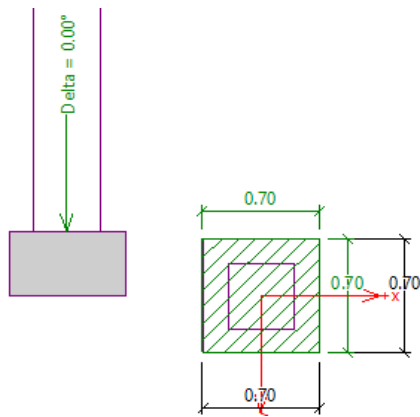
Shape of contact stress : rectangle  
 Most unfavorable load case No. 1, (Load No. 1)  
 Design bearing capacity of found.soil  $R_d = 1001.97$  kPa  
 Extreme contact stress  $\sigma = 112.89$  kPa

Factor of safety = 8.88 > 1.50

Shape of contact stress : rectangle  
 Most unfavorable load case No. 1. (Load No. 1)  
 Design bearing capacity of found.soil  $R_d = 997.11$  kPa  
 Extreme contact stress  $\sigma = 630.47$  kPa

Factor of safety =  $1.58 > 1.50$   
 Bearing capacity in the vertical direction is **SATISFACTORY**

**Figure 5.** Bearing Capacity Analysis of Marikuppam Soil

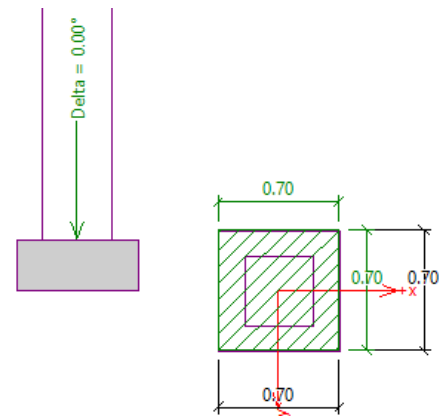
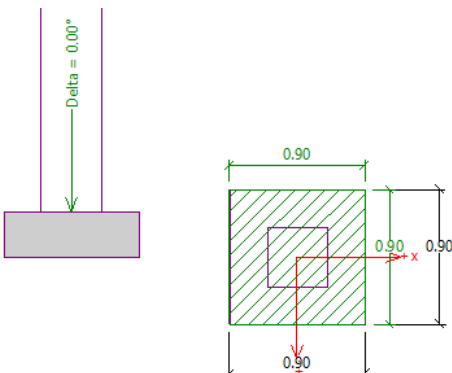
Shape of contact stress : rectangle  
 Most unfavorable load case No. 1. (Load No. 1)  
 Design bearing capacity of found.soil  $R_d = 599.66$  kPa  
 Extreme contact stress  $\sigma = 627.82$  kPa

Factor of safety =  $0.96 < 1.50$   
 Bearing capacity in the vertical direction is **NOT SATISFACTORY**

Shape of contact stress : rectangle  
 Most unfavorable load case No. 1. (Load No. 1)  
 Design bearing capacity of found.soil  $R_d = 600.53$  kPa  
 Extreme contact stress  $\sigma = 387.61$  kPa

Factor of safety =  $1.55 > 1.50$   
 Bearing capacity in the vertical direction is **SATISFACTORY**

**Figure 6.** Bearing Capacity Analysis of CN Site Soil

way and found that the footing dimension of 0.7 x 0.7 m was not sufficient (Figure 6). The revised dimension of 0.9 x 0.9 m yielded an economical design with a factor of safety of 1.55 and bearing capacity of 600.53 kPa. The economical footing dimensions obtained for Coromandel

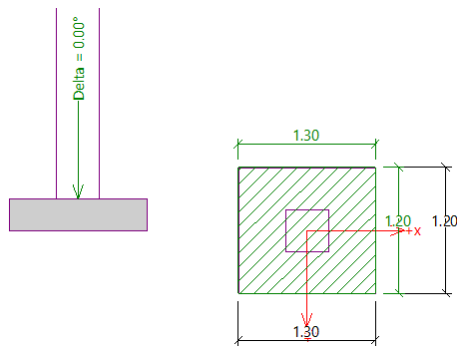
Shape of contact stress : rectangle  
 Most unfavorable load case No. 1. (Load No. 1)  
 Design bearing capacity of found.soil  $R_d = 327.32$  kPa  
 Extreme contact stress  $\sigma = 210.77$  kPa

Factor of safety = 1.55 > 1.50  
 Bearing capacity in the vertical direction is SATISFACTORY

**Figure 7.** Bearing Capacity Analysis of Coromandel Site Soil

and Champion Reef soils were 1.2 x 1.3 m and 1.5 X 1.5 m, respectively (Figures 7 and 8). The bearing capacities obtained for Coromandel and Champion Reef soils corresponding to these dimensions were estimated as 327.32 kPa and 240.45 kPa, respectively.

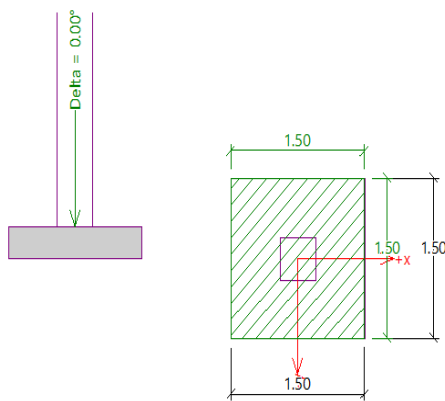
Shape of contact stress : rectangle  
 Most unfavorable load case No. 1. (Load No. 1)  
 Design bearing capacity of found.soil  $R_d = 240.45$  kPa  
 Extreme contact stress  $\sigma = 152.20$  kPa

Factor of safety = 1.58 > 1.50  
 Bearing capacity in the vertical direction is SATISFACTORY

**Figure 8.** Bearing Capacity Analysis of Champion Reef Site Soil

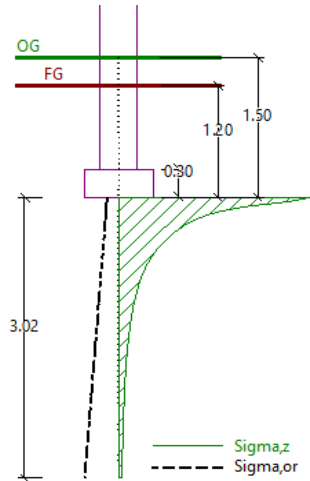
**Figure 9.** The Estimated Settlement of Marikuppam Soil

**Foundation stiffness:**  
 Average modulus of deformation  $E_{def} = 7.79 \text{ MPa}$   
 Foundation in the longitudinal direction is rigid ( $k=303.21$ )  
 Foundation in the direction of width is rigid ( $k=303.21$ )

**Overall settlement and rotation of foundation:**  
 Foundation settlement = 13.5 mm  
 Depth of influence zone = 3.02 m  
 Rotation in direction of x = 0.000 ( $\tan^*1000$ ); (0.0E+00 °)  
 Rotation in direction of y = 0.000 ( $\tan^*1000$ ); (0.0E+00 °)

The settlements that may occur at four locations of the study area were analyzed by taking the economical dimensions that were obtained from the bearing capacity analysis. The results of settlement analyses corresponding to four locations are shown in Figures 9-12. The estimated settlements respectively, for Marikuppam soil, CN site soil, Coromandel soil and Champion Reef soil are 13.5 mm, 10.5 mm, 7.4 mm and 6.1 mm which are less than the permissible settlement (25 mm). A parametric study was conducted to know the variations in the settlement values with the applied load. The settlements corresponding to vertical loads of 300 kN, 400 kN, 500 kN, 600 kN, 700 kN, 800= kN, 900 kN and 1000 kN were estimated with respect to each location of the study area (Table 6). From this table, it can be observed that the settlements corresponding to vertical load of 600 kN and above are above 25 mm. The effective

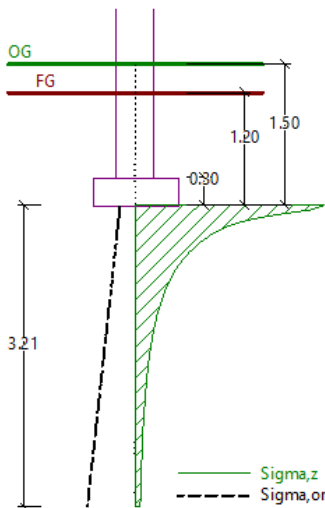
**Figure 10.** The Estimated Settlement of CN Site Soil

**Foundation stiffness:**  
 Average modulus of deformation  $E_{def} = 7.79 \text{ MPa}$   
 Foundation in the longitudinal direction is rigid ( $k=142.66$ )  
 Foundation in the direction of width is rigid ( $k=142.66$ )

**Overall settlement and rotation of foundation:**  
 Foundation settlement = 10.5 mm  
 Depth of influence zone = 3.21 m  
 Rotation in direction of x = 0.000 ( $\tan^*1000$ ); (0.0E+00 °)  
 Rotation in direction of y = 0.000 ( $\tan^*1000$ ); (0.0E+00 °)

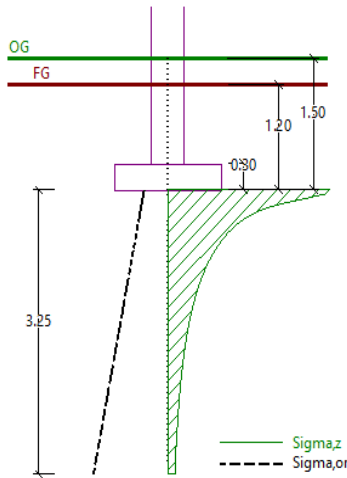
Figure 11. The Estimated Settlement of Coromandel Site Soil

Average modulus of deformation  $E_{def} = 7.79 \text{ MPa}$   
 Foundation in the longitudinal direction is rigid ( $k=47.34$ )  
 Foundation in the direction of width is rigid ( $k=60.19$ )

Foundation settlement = 7.4 mm  
 Depth of influence zone = 3.25 m  
 Rotation in direction of x = 0.000 (tan\*1000); (0.0E+00 °)  
 Rotation in direction of y = 0.000 (tan\*1000); (0.0E+00 °)

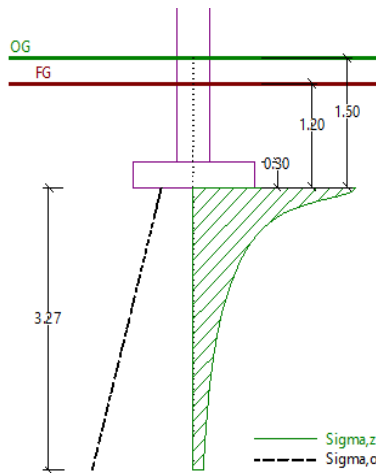
Figure 12. The Estimated Settlement of Champion Reef Site Soil

Average modulus of deformation  $E_{def} = 7.79 \text{ MPa}$   
 Foundation in the longitudinal direction is rigid ( $k=30.81$ )  
 Foundation in the direction of width is rigid ( $k=30.81$ )

Foundation settlement = 6.1 mm  
 Depth of influence zone = 3.27 m  
 Rotation in direction of x = 0.000 (tan\*1000); (0.0E+00 °)  
 Rotation in direction of y = 0.000 (tan\*1000); (0.0E+00 °)
