FRACTOGRAPHIC ASPECTS OF STRESS CORROSION FAILURE OF ZIRCALOY-2 IN CH₃OH/HCL SOLUTIONS

M. A. Golozar

Department of Materials
Isfahan University of Technology
Isfahan, Iran

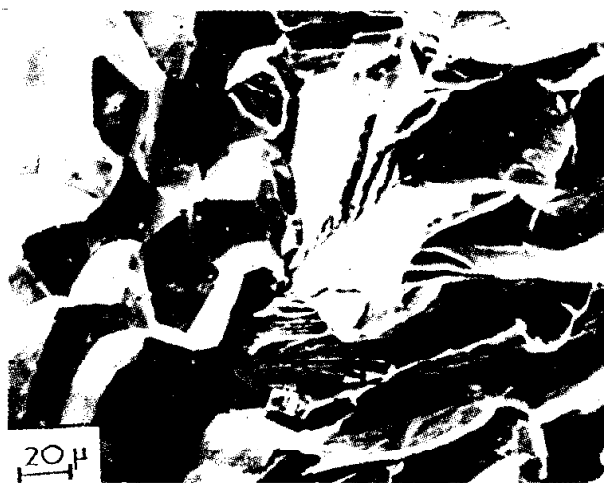
Figure 4. «River patterns» transgranular cleavage: $6.6 \times 10^{-3} \mu\text{m s}^{-1}$

In general the fracture surfaces of all grained specimens fractured in $\text{CH}_3\text{OH}/0.4\% \text{ HCl}$ with and without selenium addition were similar to that observed for fine grained material. However, the transgranular cleavage observed on coarse grained specimens was more pronounced than on the fine grained ones. An area of a fracture surface consisting of transgranular cleavage characterized by «river patterns» is shown in

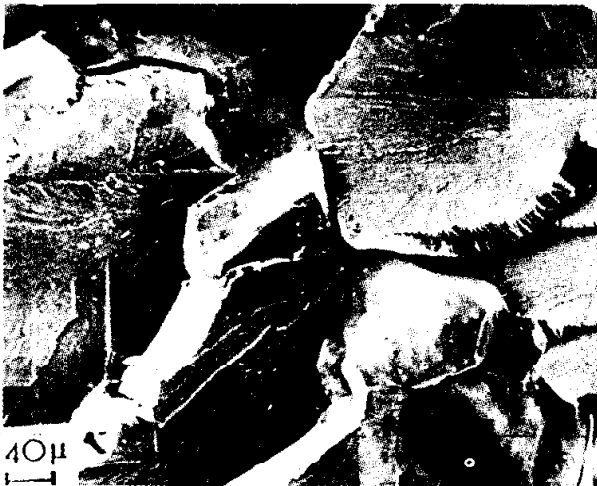
Figure 5. «Fan shaped» cleavage facets: $6.6 \times 10^{-3} \mu\text{m s}^{-1}$

Figure 4. A part from river patterns, another special type of transgranular cleavage fracture surface feature was observed, which was named «Fan shaped cleavage facets» (Figure 5). Next to the transgranular cleavage regions, areas showing the highly parallel striations (i. e. fluting) were sometimes evident (Figure

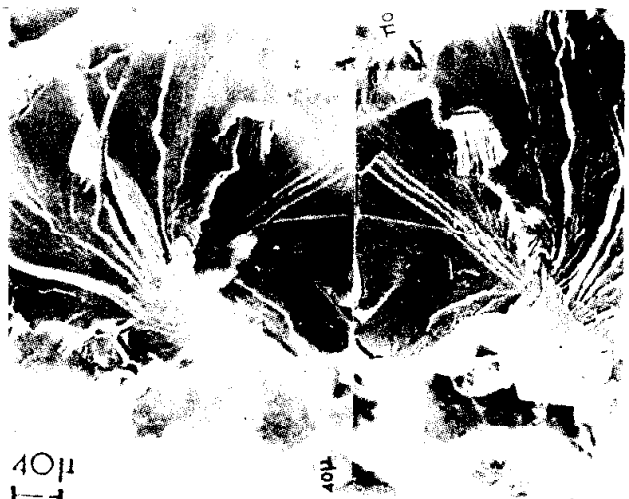
Figure 7. Fractograph of one area on both faces of the fracture surface. The complementary (interlocking) characteristic of cleavage is clearly visible: $1.6 \times 10^{-3} \mu\text{m s}^{-1}$

Examination of both faces of fractured specimens containing both cleavage and striations (fluting) revealed more information about the origin and nature of these types of fracture surface features. The cleavage areas were always complementary, i. e. interlocking surfaces. This is apparent in Figure 7, where corresponding areas appear raised on one surface but depressed on the other surface. However, unlike cleavage features, the flutings are not complementary. In this case, corresponding features of the striations are raised or depressed on both surfaces, so that the striations have a mirror image print of one surface with the other.

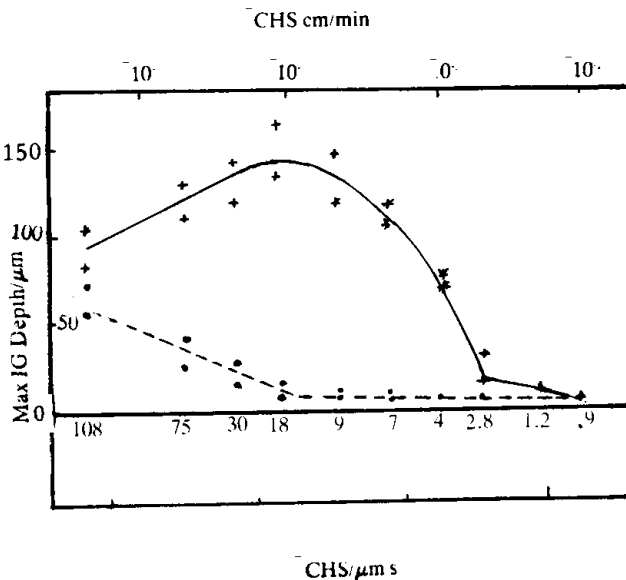
Figure 9: The maximum intergranular zone depth in corroded (●—●) and stress corroded (★—★) specimens: $\text{CH}_3\text{OH}/0.4\% \text{HCl}/25 \text{ppm}$ selenium

In order to elucidate the nature and mechanism of intergranular and transgranular cleavage features observed during the course of this work, the maximum zone depth of intergranular corrosion was compared with the maximum zone depth of intergranular stress corrosion (Figures 8, 9). This comparison was made for identical periods of exposure. Also, the maximum zone depths of intergranular, transgranular cleavage and ductile tearing on the fracture surfaces of stress corrosion cracked specimens in both solutions, i. e. with and without selenium additions, were measured and compared (Figures 10, 11).

Figures 8 and 9 show that, for both solutions, over a wide range of crosshead speeds the intergranular separation of stress corroded specimens is more than corroded ones. This can easily be explained as arising from stress/strain assisted dissolution. At very high crosshead speeds, i. e. more than $1 \mu\text{m s}^{-1}$, the difference might be expected to disappear. This is because such experiments occupy a very short period of time.

At the very low end of crosshead speeds used, for $\text{CH}_3\text{OH}/0.4\% \text{HCl}$ solution, the maximum intergranular corrosion depth is more than the maximum intergranular stress corrosion depth (140 and 110 μm , respectively) while for $\text{CH}_3\text{OH}/0.4\% \text{HCl}$ solution with selenium addition, the reverse is observed (70 μm and 90 μm , respectively). This is due to the more corrosiveness effect of $\text{CH}_3\text{OH}/0.4\% \text{HCl}$ solution compared with $\text{CH}_3\text{OH}/0.4\% \text{HCl}$ solution plus 25 ppm selenium additions, as well as the more hydrogen absorption in the latter environment.

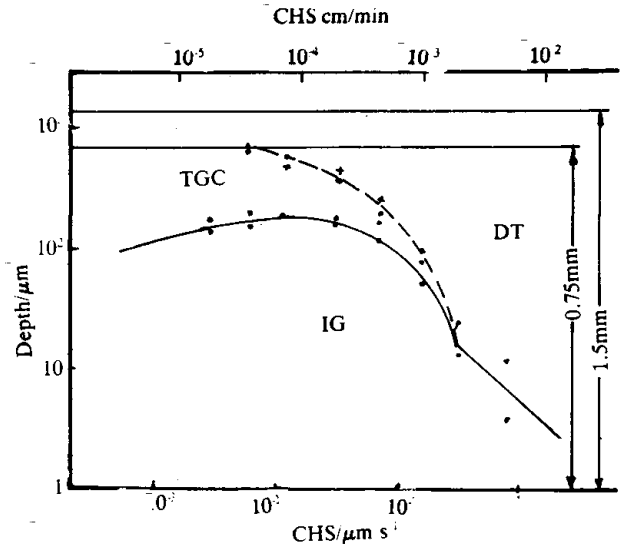
Figure 10: The maximum zone depths of intergranular, cleavage and ductile tearing: $\text{CH}_3\text{OH}/0.4\% \text{HCl}$

For the crosshead speeds lower than $10^{-2} \mu\text{m s}^{-1}$ the difference between the two types of intergranular is reduced again. It can be seen that it is replaced by transgranular cleavage (Figures 10, 11). The disappearance of stress assisted intergranular fracture and replacing it by transgranular cleavage could be explained by the effect of the applied crosshead speed upon the imposed stress. As the applied cross head speed is lowered the time taken to initiate the intergranular stress corrosion will increase. During all this time hydrogen is being absorbed. In the

Comparison of Figures 10 and 11 show that, at a given crosshead speed, the amount of transgranular cleavage observed on the fracture surface of the specimens broken in $\text{CH}_3\text{OH}/0.4\% \text{HCl}$ solution with 25 ppm selenium addition is always more than that observed in $\text{CH}_3\text{OH}/0.4\% \text{HCl}$ solution without it. The observed effect due to the addition of selenium cathodic poison upon the fracture surface features is consistent with the previously proposed function of absorbed hydrogen atoms, produced by cathodic reaction (i. e. $\text{H}^+ + \text{e} \rightarrow \text{H}_{\text{atm}}$).
