International Journal of Engineering

Simple Slope Stabilization on Quartz Sandstone using Horizontal Drain

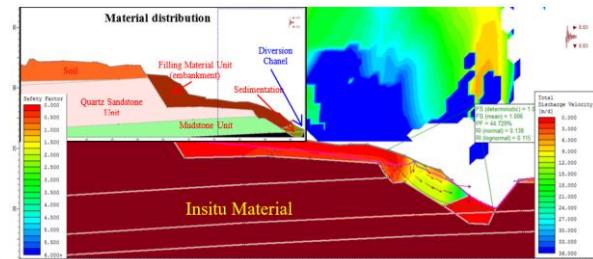
Figure 3. Back analysis on stage of 90 days showing total discharge velocity and accumulation on the slope surface of the fill material embankment. Insert shows material boundaries distribution

not occur at once but slowly creeping. Figure 3 shows the result of back analysis on stage of 90 days. The surface of fill material slope is a groundwater accumulation zone, where the flow in that part is the greatest. This is in accordance with the result of field identification that has been carried out that the groundwater condition greatly affects the stability of fill material.

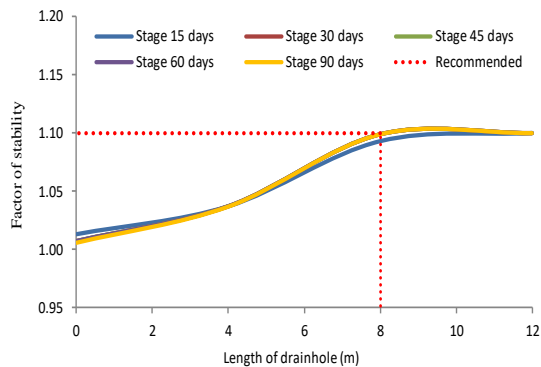
Figure 5. Corelation between length of horizontal drain and factor of stability on various stages of time

To determine the effect of horizontal drain length on the values of stability factor and failure probability, modeling was carried out by correlating the stability factor (Figure 5) and the failure probability (Figure 6) with the horizontal drain length. In the correlation, the initial condition without drainhole installation is illustrated as the horizontal drain length of 0 m.

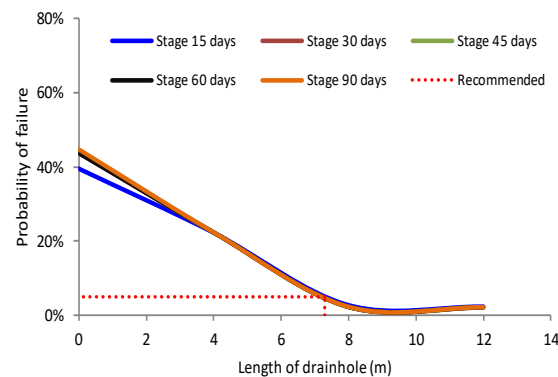
Figure 6. Corelation between length of horizontal drain and probability of failure on various stages of time
